Manhole Inspection Summary

Manhole # S47AA_029MH

Insp Date: **6/20/08 1:02 PM**

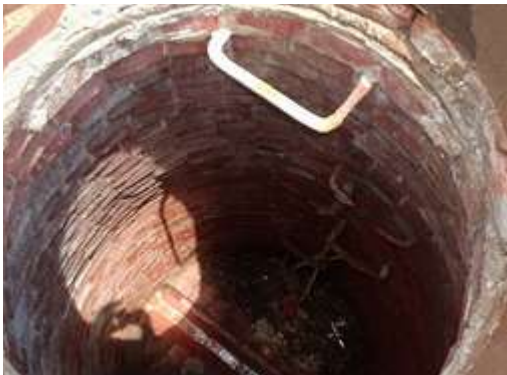
Defect 2

Count: **5** Missing: **3** ☒ **Corroded**

broken step

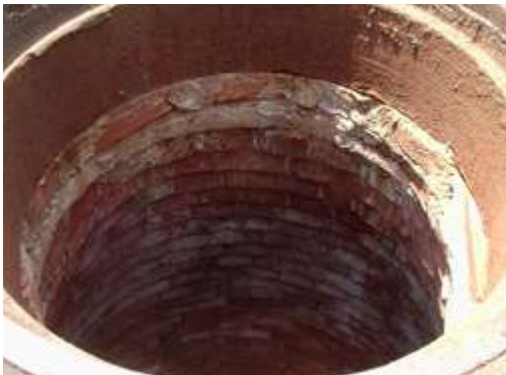
Defect 1

Infiltration: ☐ None ☐ Joint ☐ Cracks ☒ **Mortar** ☐ Roots ☐ Wall

infiltration

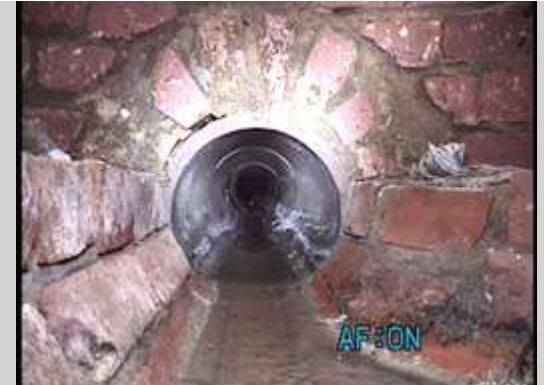
12 O'Clock Outflow

Pipe Height: **8.4** (in.) Rod and Bar (Angled)
Pipe Material: **Clay** ☐ Pipe Lined
Invert Depth: **9.90** (ft.) Flow Characteristics: **Slow**
Deposits: ☒ None ☐ Mud ☐ Sludge ☐ Debris ☐ Grease
Silt Depth: (in.) Deposits Extent:
Infiltration: **None** Pipe Seal Cond: **Sound**

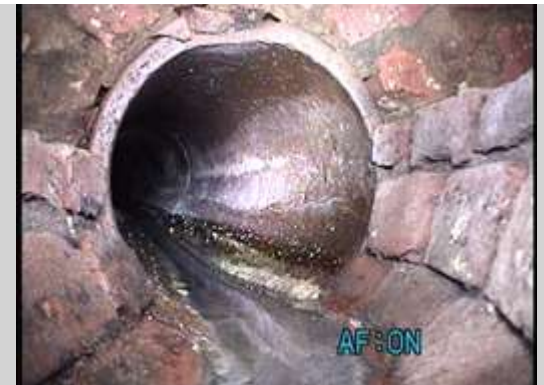
3 O'Clock Inflow

Pipe Height: **8.4** (in.) Rod and Bar (Angled)
Pipe Material: **Clay** ☐ Pipe Lined
Invert Depth: **9.85** (ft.) Flow Characteristics: **Slow**
Deposits: ☒ None ☐ Mud ☐ Sludge ☐ Debris ☐ Grease
Silt Depth: (in.) Deposits Extent:
Infiltration: **None** Pipe Seal Cond: **Sound**

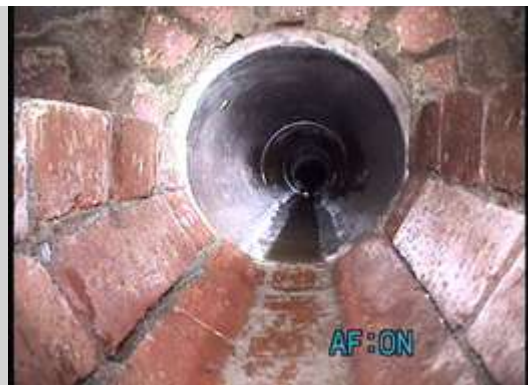
6 O'Clock Inflow

Infiltration: **None** Pipe Seal Cond: **Sound**
